# Estonian Road Traffic Safety Audit Project

## Highway 3 Jõhvi-Tartu-Rõngu

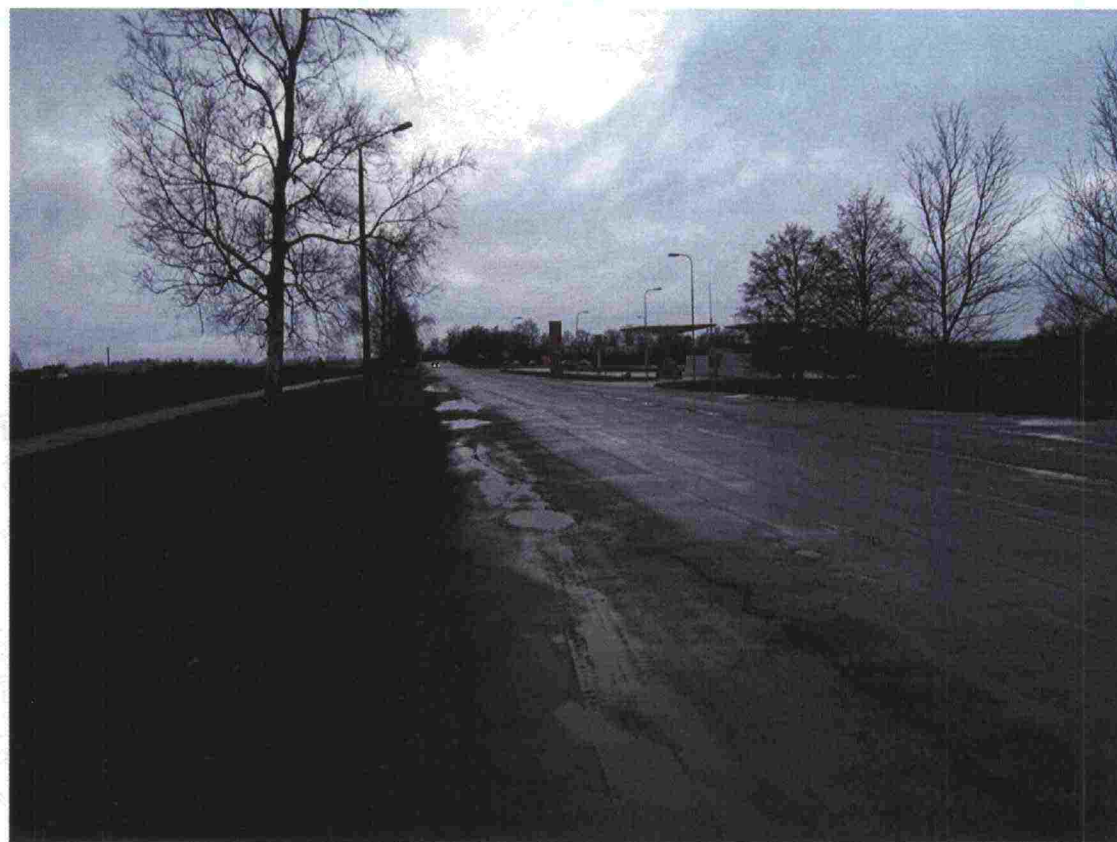
*Picture 5.10. Beginning part of the highway no 3 in Jõhvi.*

On the beginning part of the road there are two railway crossings leading to "burning stone" mines. Only the other crossing is somehow warned. If the railway crossing is needed it should be developed with sufficient warning system or solved with some other possibilities.

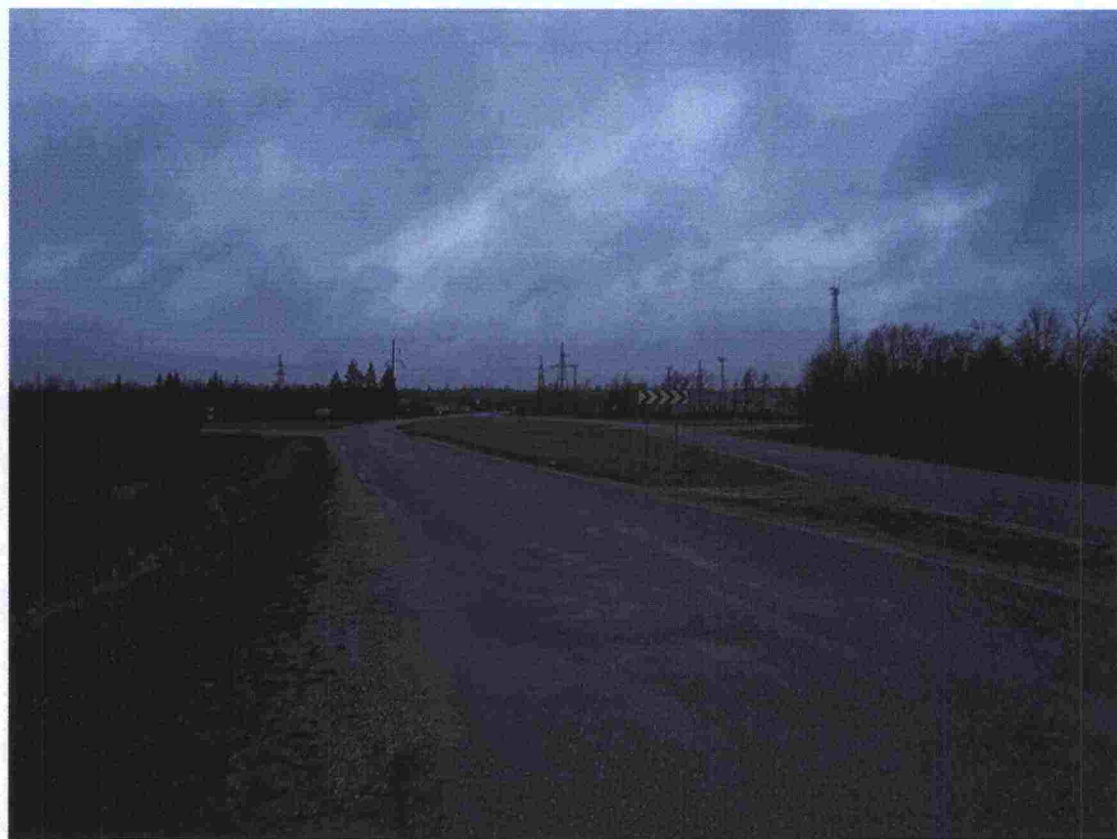
Picture 5.11. Mustvee crossing, picture taken from south.

The section ends to Mustvee crossing (see picture 5.11). The intersection type is quite exceptional from the normal crossing types, although this type of crossing is seen safer than normal X-crossing. The AT suggests to replace the crossing with large roundabout in order to prevent high speeds on the priority way. Roundabout type intersection as presented in the picture 5.12. is more common and much more systematic for all road users to understand. In AT's opinion this type would prevent also stops in the intersection area, which AT saw during the auditing.

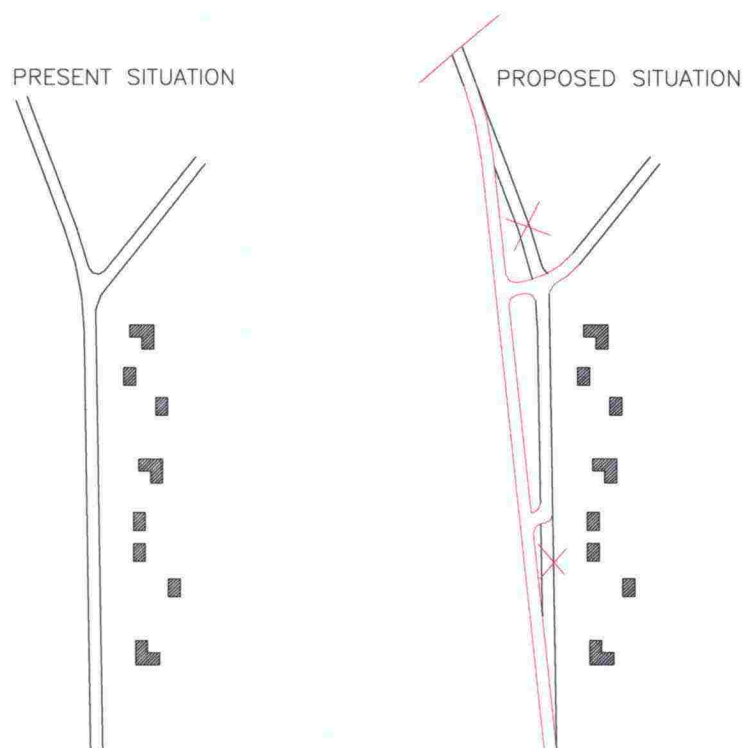
*Picture 5.14. Selling place south of Mustvee intersection.*

Pedestrian accidents relate on the part of village Raja, where local people gather along the road to sell their articles to the passers-by. AT sees the best way to get the situation improved is to build a separate place for all sellers on the eastern side of the road. When constructing the separate sellers'/resting area, old road can be used to this purpose. This idea is presented in the picture 5.14. The realisation of this idea would need the co-operation of the local sellers. After construction of the separate selling/resting area the selling along the road would be prohibited as well as the parking of the vehicles beside the road. The selling area should be dimensioned for both all sellers and parking vehicles.

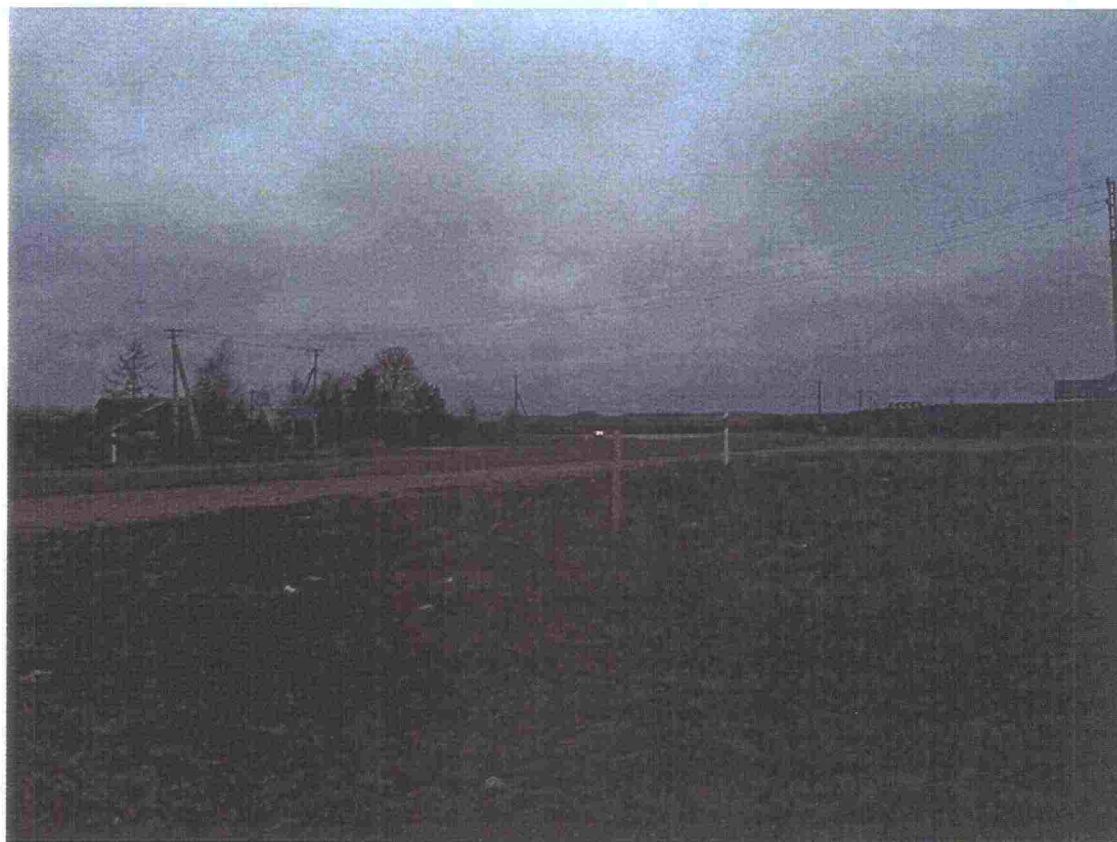
*Picture 5.17. Aovere intersection.*

Some pedestrian/bicycle accidents as well as running off the road- accidents occur between Vedu and Aovere. Between Aovere and Aru the accident types are different. Better markings, proper lighting and intersection arrangements would improve traffic safety of the car traffic. In a long run separate NMT-lane would be needed between Tartu and Aovere. Widening of the road could be sufficient enough north of Aovere. The lighting would improve the optical guidance as well, which is insufficient e.g. in the intersection in Aovere situated in a curve (see picture 5.17.)

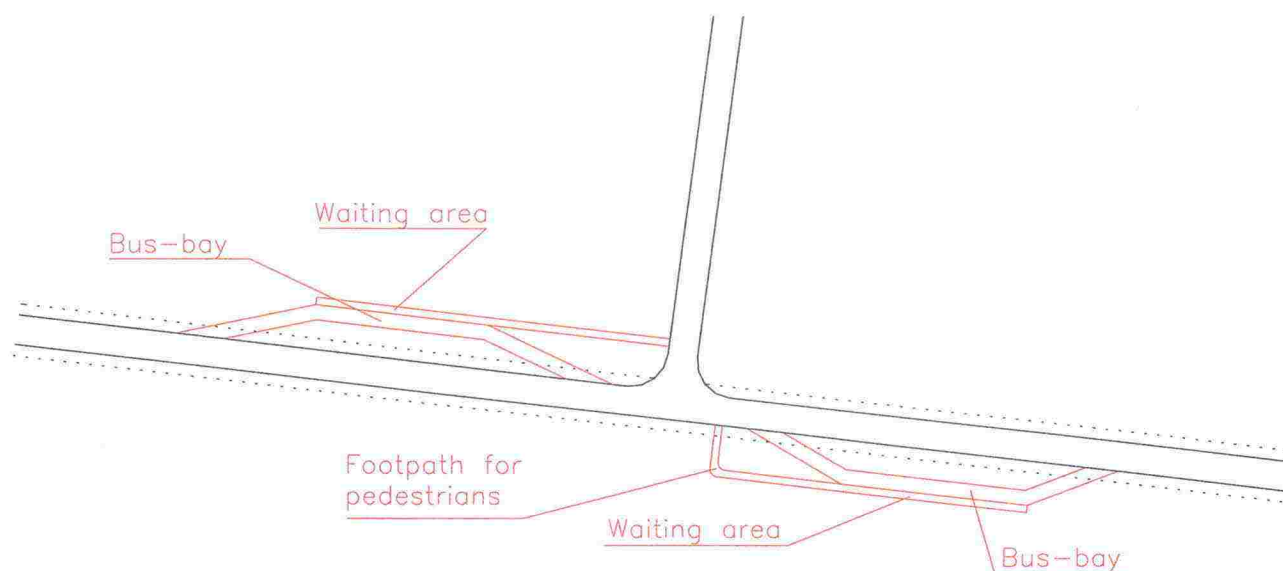
Picture 5.19. Bus-bays proposed to Kõlitse.

In a long run a separate pedestrian way all the way to the Nõo would be needed, when improving the status of non-motorised road users. Some accidents are related to the bus traffic., when the NMT has overcrossed the carriageway. The best way to get rid of such accidents is to construct an underpassage for the NMT: AT sees that because of flat landscape the underpassage would not be a perfect solution in Kõltsa. It is too easy to cross the road from the bus stop direct. Therefore proper bus-bays (see picture 5.19) with some transition from the carriageway are needed at least in Kõltsa. The purpose of separate bus-bay outside the road would affect so that the NMT couldn't rush then direct across the road. These bus-bays both sides of the road could be constructed immediately.

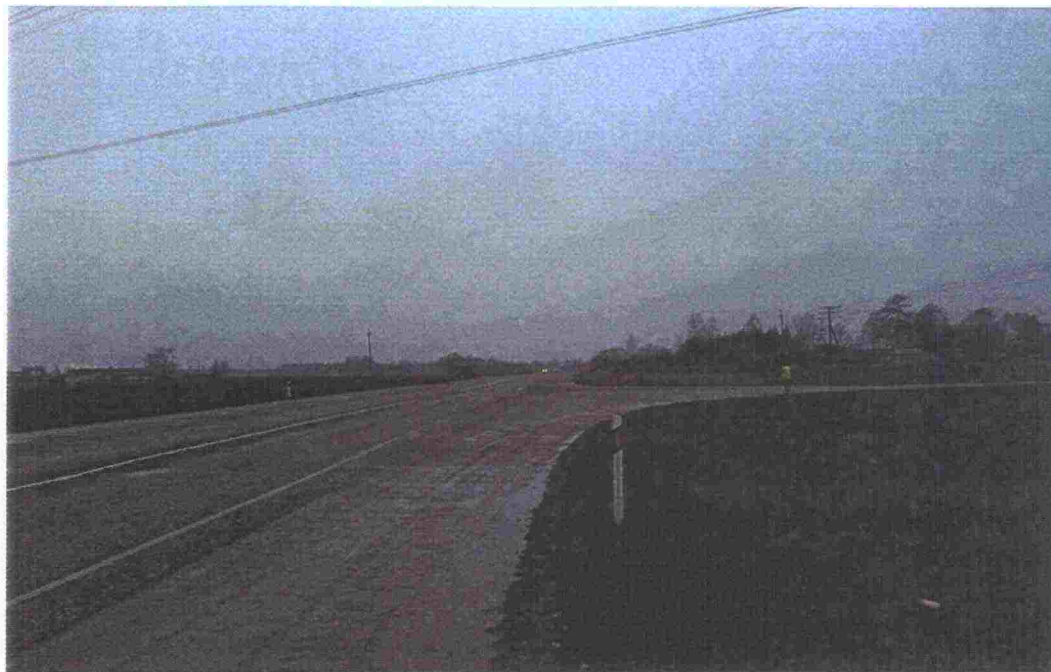
*Picture 5.21. Black spot of Kõlitse.*

AT sees at least in Rāni and Kūlitse the most serious problem is the one related to the pedestrian and bicycle traffic.

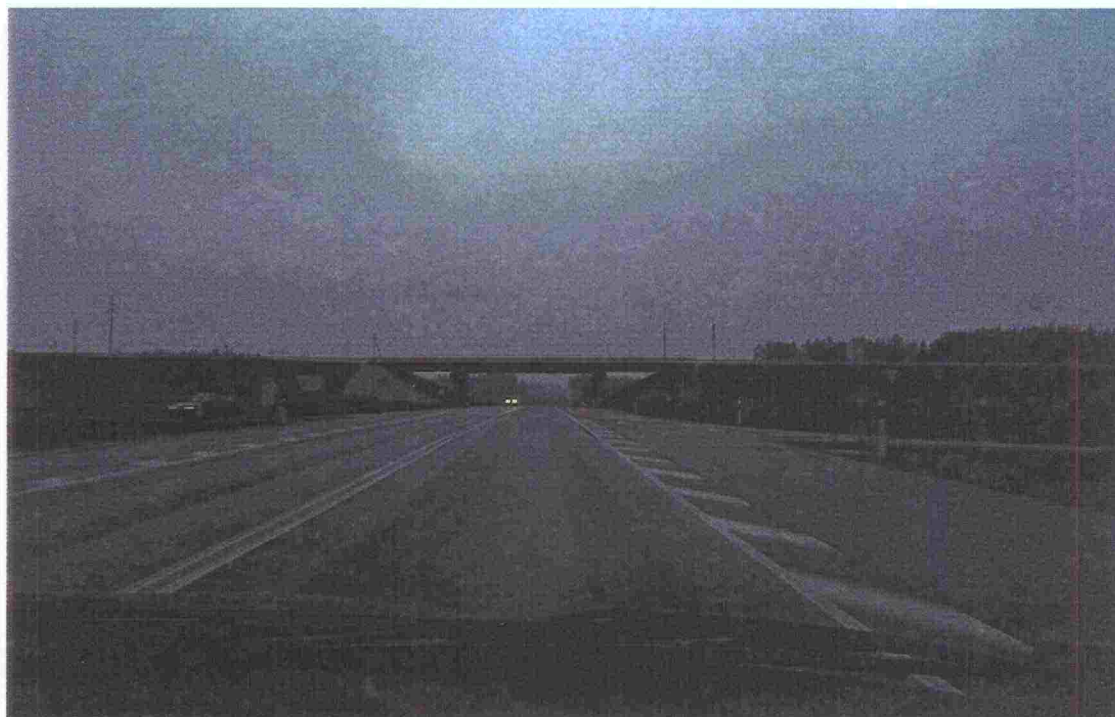
*Picture 5.22. Interchange for Elva on the new by-pass section.*

This section is brand new, while it is taken to use in autumn 2000. The alignment is mostly straight and the sights (large curve to south left) are mostly excellent. The guide posts are erected every 50 metres and there are no minor junctions. AT sees although the most hazardous spots on this section are the intersections. Many of the intersections have been built in the X-form although there would have been space enough to stagger them or to multigrade them.

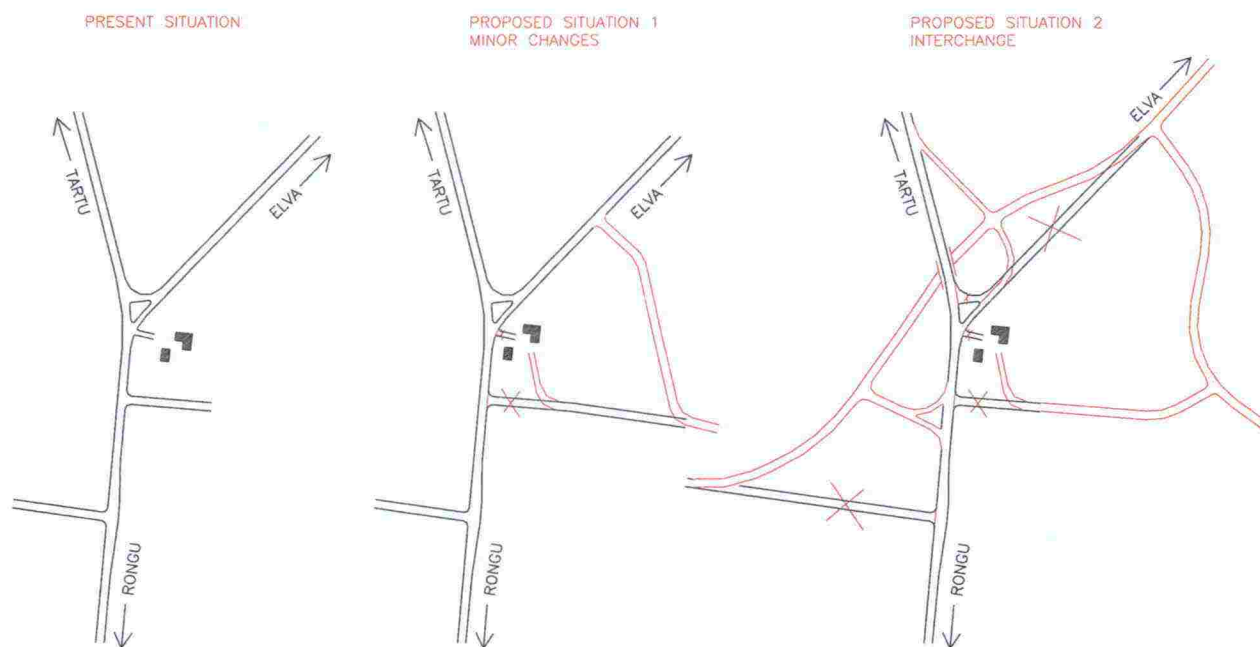
Picture 5.24. Intersection at the end of the by-pass of Elva in Kalme.

One of the most hazardous intersections is situated in Kalme in the southern end of the by-pass of Elva. There are too many intersections to the main road at one spot. To make even more confusion a yard access is allowed to a place, where old highway exits towards Elva. Two possible solutions are presented to replace the current situation (see picture 5.24.). Main purpose of the proposed solutions is to minimise the amount of the intersections on the main road.

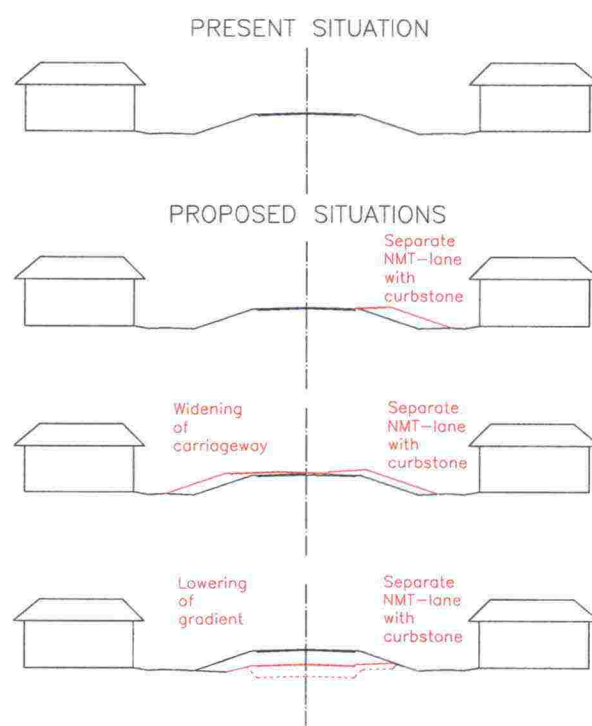
Picture 5.26. Rõngu cross-section.

In Rõngu the road is situated on a embankment both sides of the town. The houses are quite close to the road, so in some places it might be difficult to construct a separate NMT-lane. Some possible solutions are presented in the picture 5.26. The solution suits the best to the town landscape and needs less extra road area is the lowest, where gradient of the road is lowered.
